# Hudson River Shoreline Stabilization Study

Albany, New York

## Study

June 2021

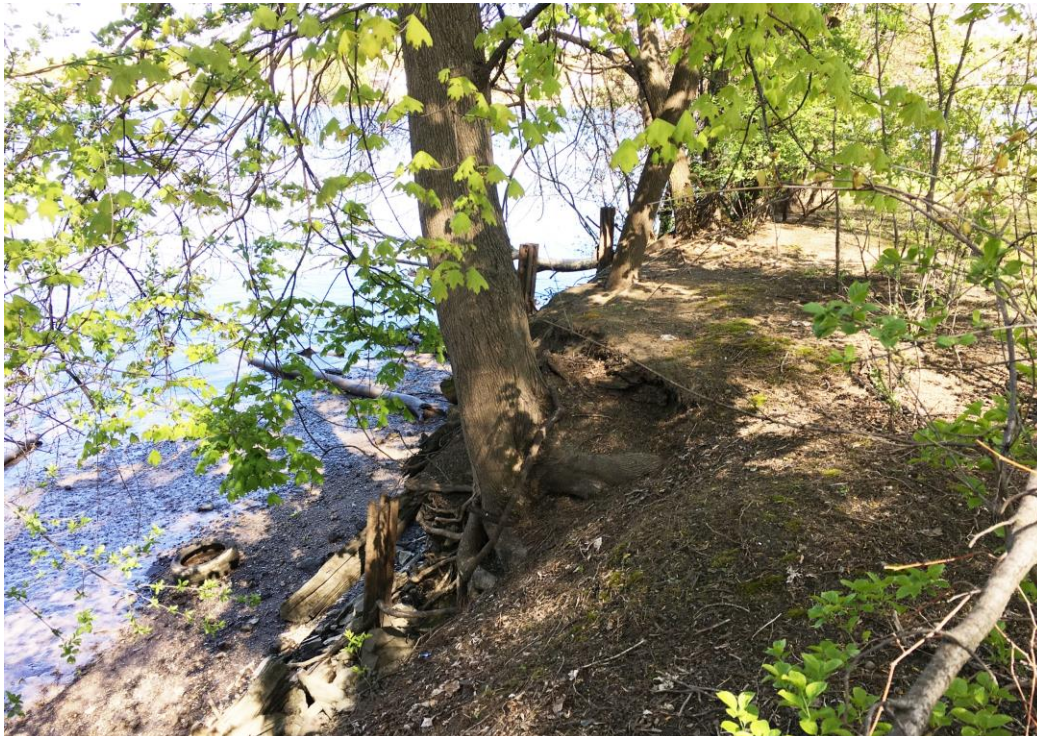
Figure 2: Eroded shoreline conditions at Island Creek Park

- Tree decline, timber retaining structure failure, and erosion at Island Creek Park.
- Insufficient vegetative buffer and steeply sloped riprap edges at the Corning Riverfront Park.
- Development encroachment and insufficient shoreline buffer in commercial, privately owned properties in the southern section of the project area.
- Deteriorating bulkhead near the Corning Riverfront Park Boat Launch.
- Steep slopes with stressed trees along the Mohawk Hudson Bike Path in the southern portion of the Riverfront Preserve.

Island Creek Park is identified as a high priority tier 1 project because the park's existing shoreline infrastructure is deteriorating rapidly and the trees adjacent to the shore are subject to collapse into the river. The deterioration of the shoreline significantly impacts surrounding park spaces and presents a potential safety hazard. The park is a cherished resource and is heavily used for fishing and passive recreation. Since the recommended shoreline improvements are comprised of mixed structural elements with living shoreline systems that can be designed for public access, the aesthetic, ecological, and community benefit of the project will be substantial. Finally, this park is listed as an environmental justice area by the New York State DEC and is adjacent to historically underserved neighborhoods (NYS DEC, 2021).

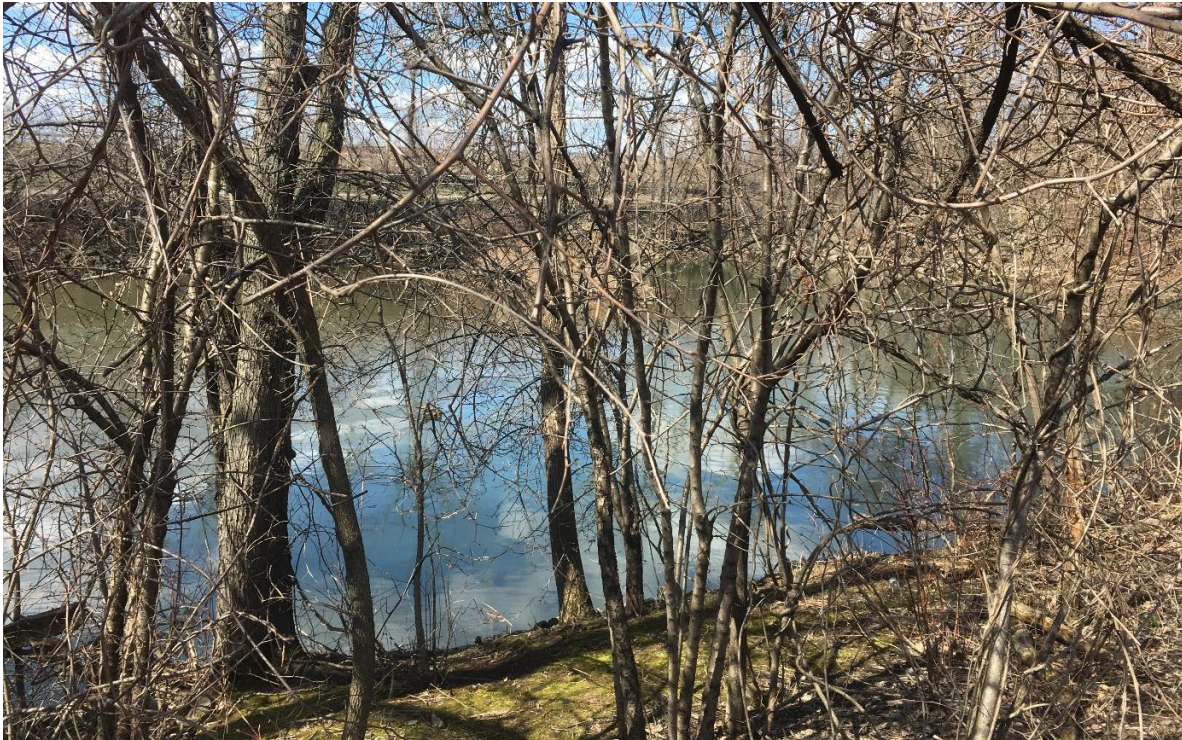
Figure 6: Riparian water and land interface at the Riverfront Preserve.

While most of the corridor has been disturbed and is highly managed for human use, the Riverfront Preserve open space provides floodplain functions, vegetated buffers, and riparian<sup>7</sup> habitat connectivity. Riparian corridors are important areas for wildlife habitat because many species live both on land and in the water. Transition zones between the water and land are typically very diverse – these areas exist in a dynamic equilibrium governed by the changing currents of the river and flux of the shoreline over time. Shoreline vegetation provides forage and shelter for a wide range of aquatic and terrestrial species. Botanically diverse riparian edges provide seeds, nuts, buds, and fruits. Fisheries rely on shade and woody debris from shoreline trees and shrubs – healthy fish and their fry<sup>8</sup> in turn provide food for a variety of mammalian, amphibian, and avian species (Cohen, 2014).

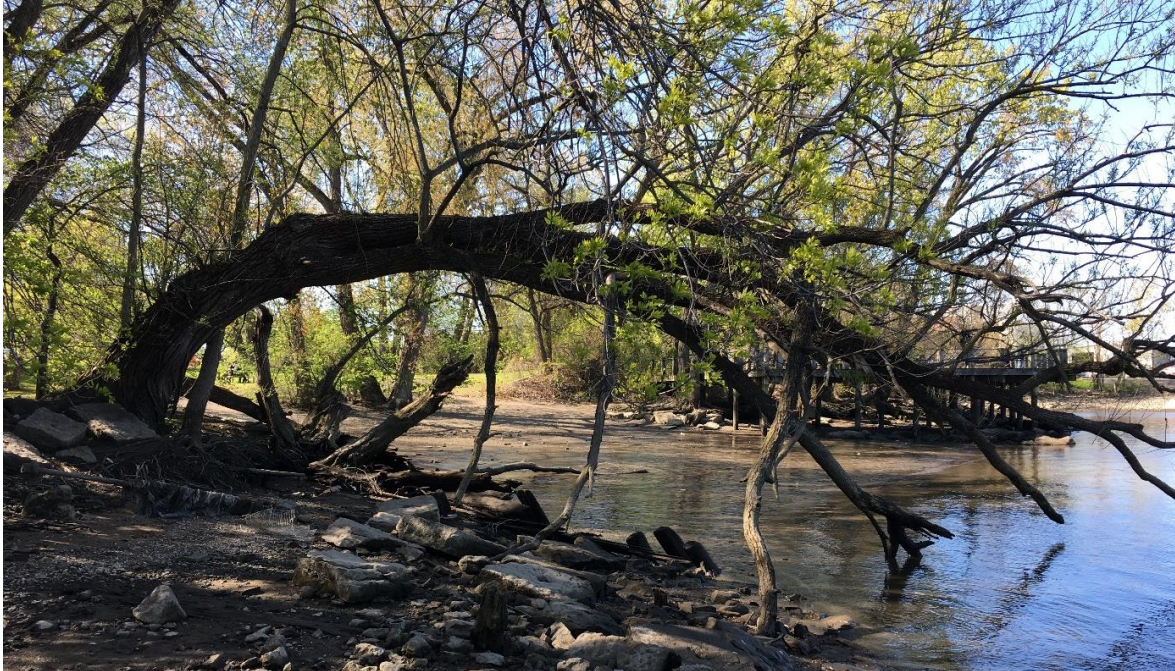
Figure 7: Declining tree at Island Creek Park.

The condition of trees in the study area varies widely due to the difference in site conditions and landscape management. In some instances, trees are simply declining due to age. As trees grow older, they are less able to compartmentalize injuries, resist decay, and retain branches. This appears to be the primary cause of the decline of *Populus deltoides* (cottonwood) trees at Island Creek Park. Alternately, trees in urban conditions are more likely to fail, especially if they are exposed to construction activities or are situated adjacent to impervious surfaces and polluted runoff, as is found at the Corning Riverfront Park tidal wetlands. Another characteristic to note is the presence of pests and disease among the riparian forest canopy. For example, many ash trees are experiencing the detrimental effects of the emerald ash borer.<sup>9</sup> In the Riverfront Preserve, invasive *Celastrus orbiculatus* (oriental bittersweet) vine is strangling large swaths of the forest.

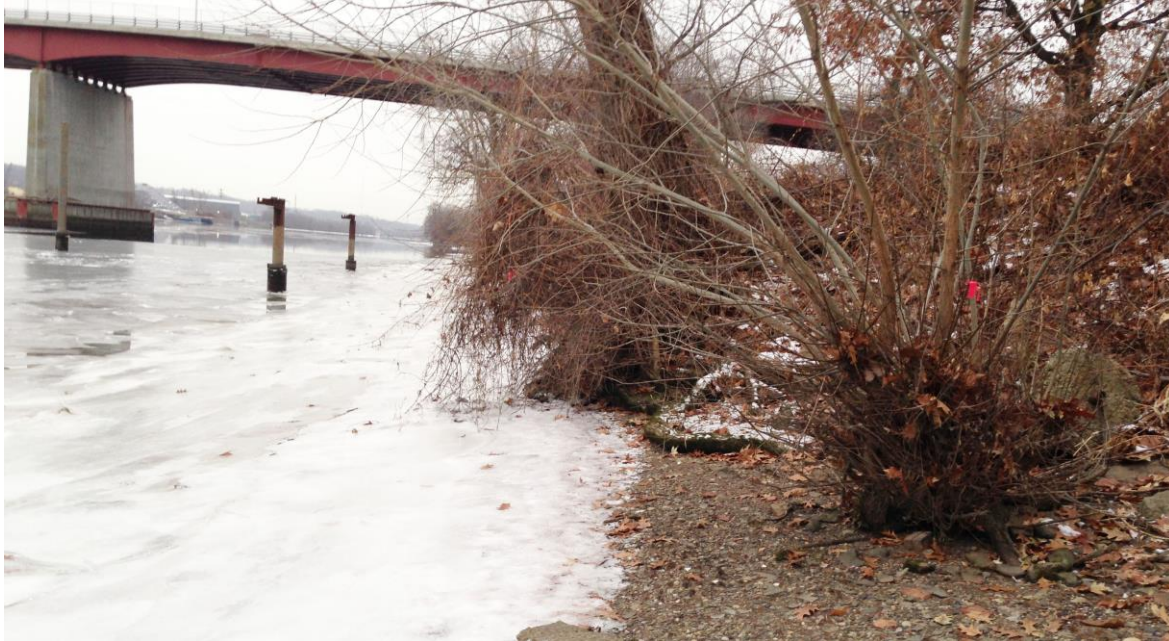
Figure 9: Ice along the shores of the Hudson River

Localized ice jams have likely resulted in the deterioration of shoreline structures within the project area over the decades. Climatological conditions have been recorded by the US Coast Guard ice breakers in the Hudson River since 2004; however, shoreline improvements are site-specific and data on the impacts of ice on these systems is limited (NYSDEC , 2015). Cooperation with agencies (US Coast Guard, Hudson River Sustainable Shorelines, Hudson River National Estuarine Research Reserve, Stevens Institute of Technology) studying ice dynamics will yield valuable information to guide restoration activities along the Hudson River.

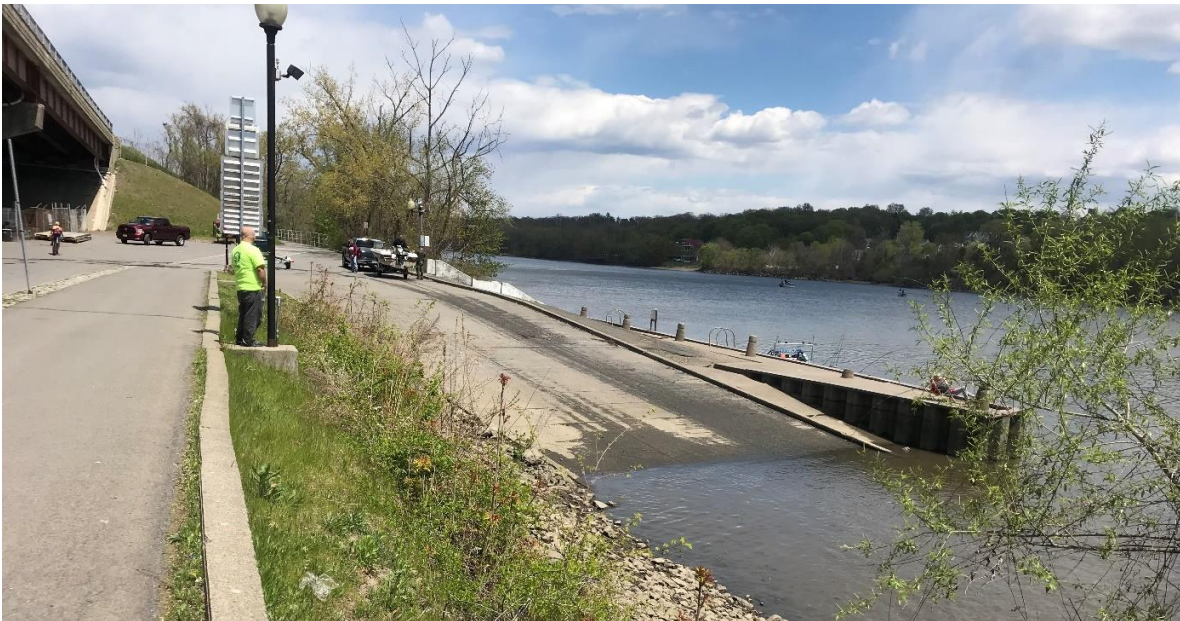
Figure 11: Existing Corning Riverfront Park boat launch.

Reconstruction of the Corning Riverfront Boat Launch is recommended to ensure the launch is safe for visitors and accommodating for a variety of boating activities. Further evaluation of the boat ramp will be required to ensure the launch is stable motor craft. An accessible soft launch for kayaks and canoes will provide expanded opportunities for recreation in the Hudson River. The bulkhead will require further evaluation for upgrades to expand opportunities for recreation.

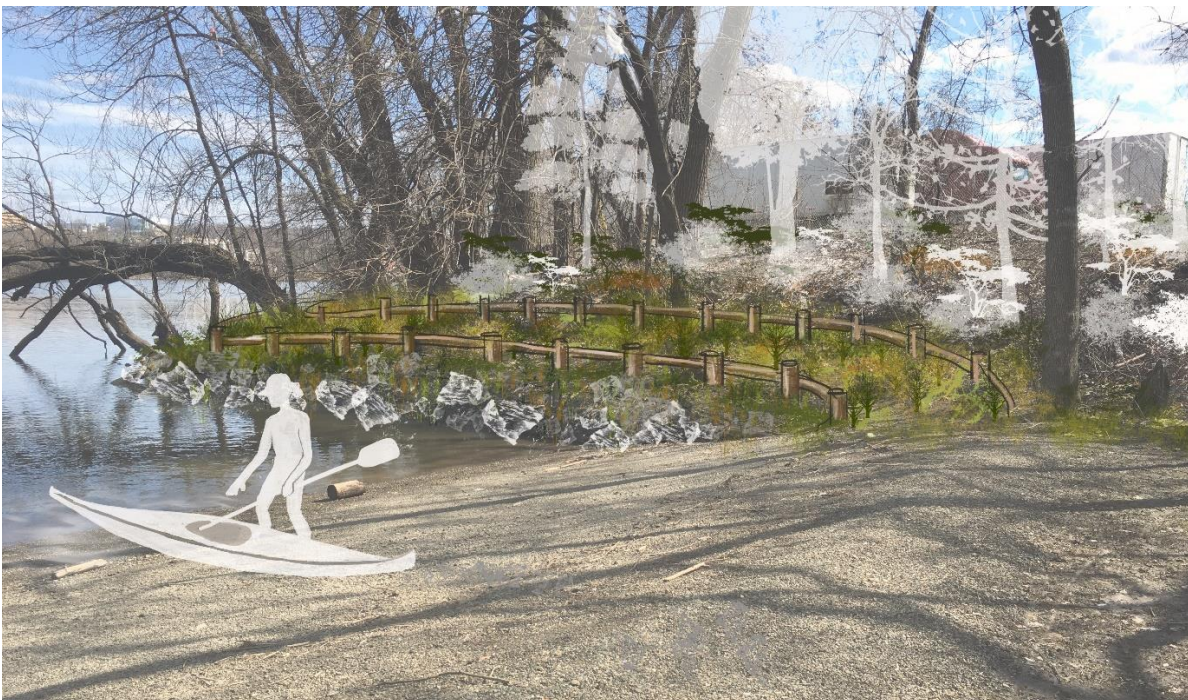
Figure 12: Island Creek Park mixed shoreline improvement concept rendering.

It is critical to establish an adequate vegetative between intensive land use areas and the water's edge. Restoration of the shoreline and expanded areas of shoreline stabilization plantings are needed where inadequate vegetative buffers exist, and the slopes are too steep to adequately support a healthy vegetative riparian corridor. Where possible, regrading of existing steep slopes to accommodate a wider vegetative buffer is highly recommended. Shallower slopes expand the area over which floodwaters must travel, and vegetation establishment will be more successful where the slope is shallow enough to secure the roots. Where there is insufficient area to regrade the slope, a tiered system of vegetated riprap or vegetated timber cribbing is recommended. Low-lying native species may be established where viewsheds are desired; however, intermittent stands of trees should also be considered to shade out invasive species and to provide stable

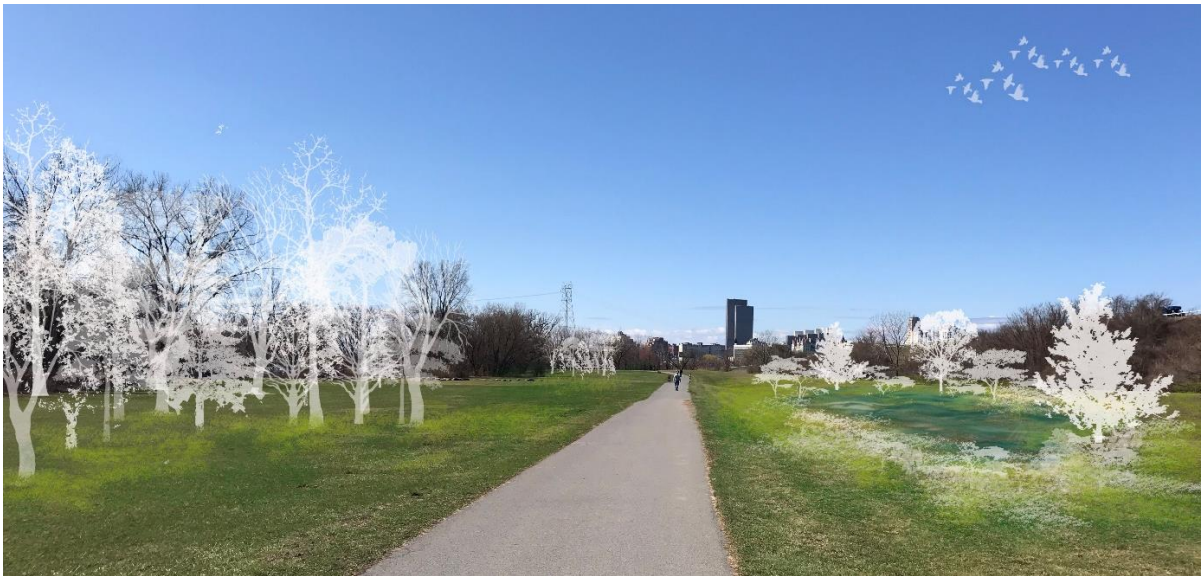
Figure 13: Riverfront Preserve riparian buffer restoration rendering

In areas where an increased width of the riparian woodland buffer is desired, additional plantings may be installed in a phased method. The extensive root systems of trees are a critical component of slope stabilization and added layer of mixed overstory and understory plantings will attract a wider range of birds and other wildlife. Tree canopy shading may also inhibit invasive encroachment in the shrub layer. Each year a row of trees, shrubs, and herbaceous native plants can be installed behind the existing woodland corridor. Over time, the width and resiliency of the vegetative buffer will gradually increase. Plant species must be carefully chosen to accomplish objectives specific to each site. If adequate room is present at the restoration site, a layer of shade tolerant herbaceous material may be planted between the shrub layer and adjacent upland landscape.

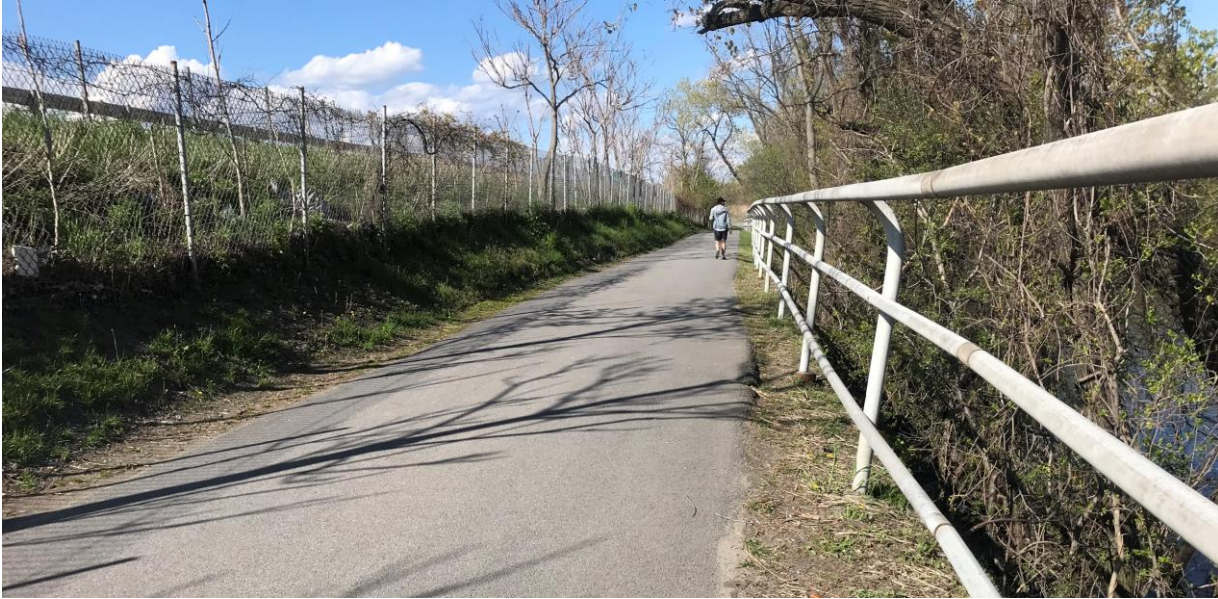
Figure 14: Pathway along I-787 at the Riverfront Preserve - the slope to the river is very steep

Pathway design within the study area is contextual. In some locations (Corning Riverfront Park, Riverfront Preserve) the relocation of the multi-use path to allow for an expanded vegetated buffer is appropriate. Some sites may be more appropriate for a smaller-width stone-dust path leading to the shore or designated overlooks. In all cases, constructing inclusive, accessible path systems is a top priority. Improvements should be welcoming to as wide a demographic as possible. A comprehensive lighting strategy along pathways will increase the usability of these systems and will increase the safety of visitors at the riverfront.

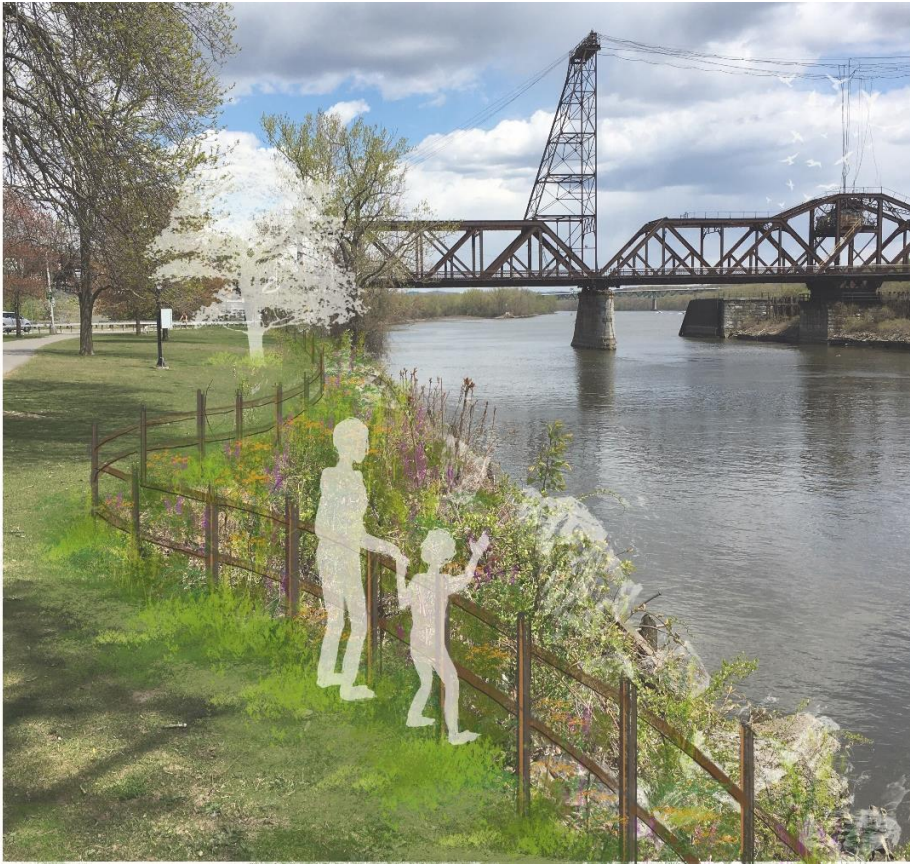
Figure 17: Corning Riverfront Park shoreline stabilization rendering

The shoreline of the Corning Riverfront Park is eroding rapidly and there is little to no stabilization system in place. These shores are often immediately adjacent to park trails and infrastructure. Each storm event sloughs more sediment into the waterway, quickly reducing the available land. Ultimately, the reconstruction of the shore becomes more expensive and labor intensive the longer this pattern continues. The popularity of the Corning Riverfront Park with its varied amenities, as well as the ongoing investment into the park, makes this worthwhile project to consider immediately. Opportunities for passive recreation, fishing, and long-term flood protection abound in this project site. Additionally, the heavily used boat launch in the park requires attention to ensure safe launching is provided for visitors and the site is welcoming to all who pass through. There exists ample community support and desire to improve this recreational destination. This enthusiasm should be capitalized upon to garner support and funding for improvements to the launch and surrounding shoreline amenities.
